INDOOR AIR QUALITY ASSESSMENT

**Berkley Town Offices
1 North Main Street
Berkley, Massachusetts**

Prepared by:
Massachusetts Department of Public Health
Center of Environmental Health
Emergency Response/Indoor Air Quality Program
January 2006

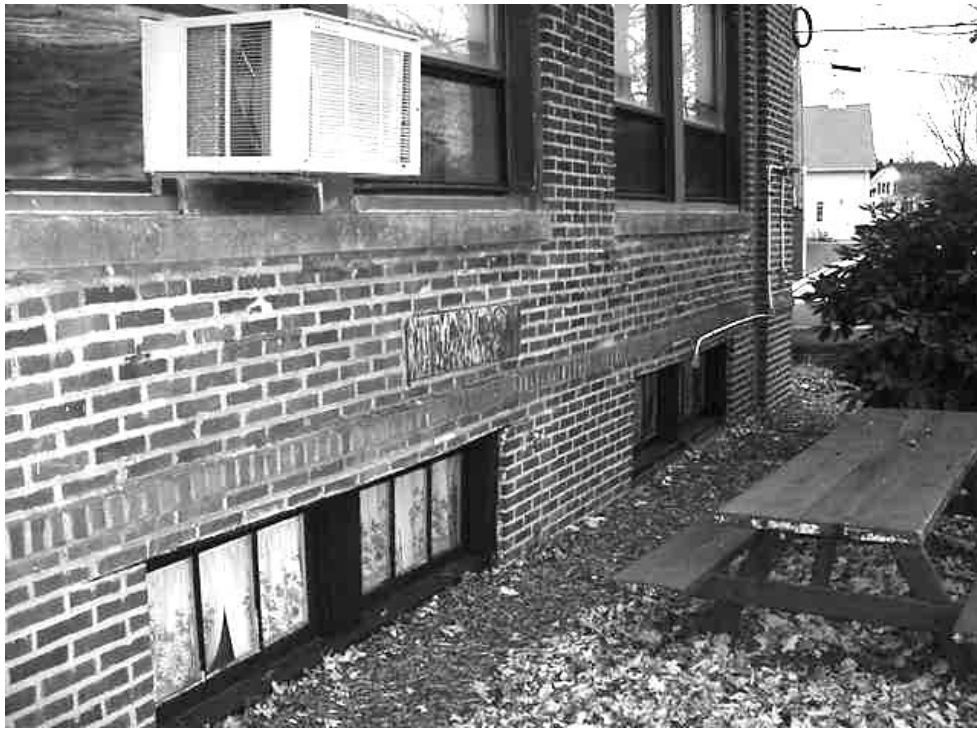
Picture 1

Fresh air ventilation was originally provided by unit ventilators (univents). Univents draw fresh air from a vent on the exterior of the building and air from the room (called return air) through a vent in the base of the unit ([Figure 1](#)). Fresh air and return air are mixed, filtered, heated and provided to rooms through a fresh air diffuser located in the top of the unit. Please note that fresh air intakes for univents were sealed with plywood (Picture 1). With the sealing of the fresh air intakes, the sole source of fresh air is through openable windows.

Sealed Fresh Air Intake

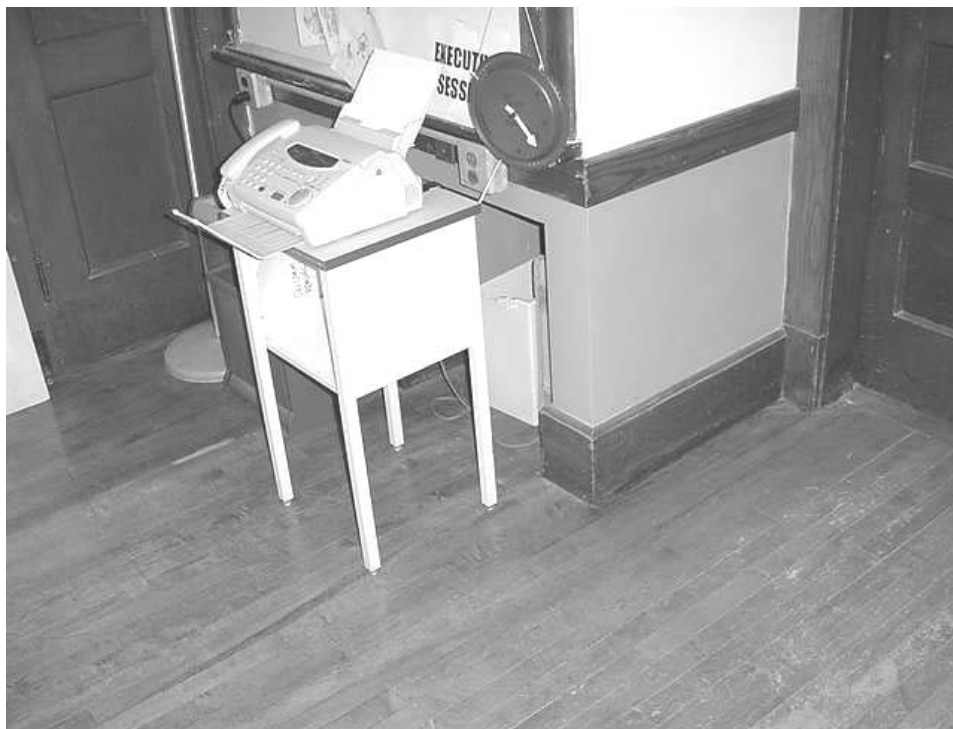
Picture 2

Exhaust ventilation is drawn into ungrated holes located at floor level (Picture 2) and vents located inside of spaces originally designed as coat closets (Picture 3). No airflow was detected from any of the exhaust vents examined. Building staff did report that closet doors would rattle during weather with high wind, which would indicate that this system is a non-mechanical, "gravity" system. A louver located inside the duct controls airflow. Above the louver is usually a heating element that creates airflow via

Exhaust Vent, First Floor

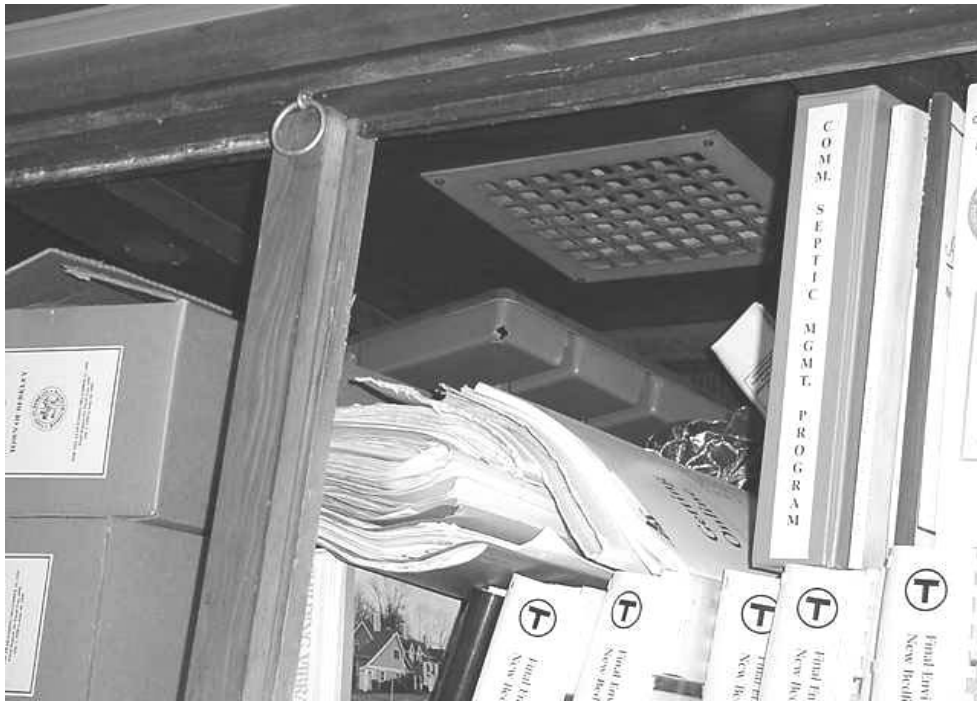
Picture 3

Exhaust Vent Closet

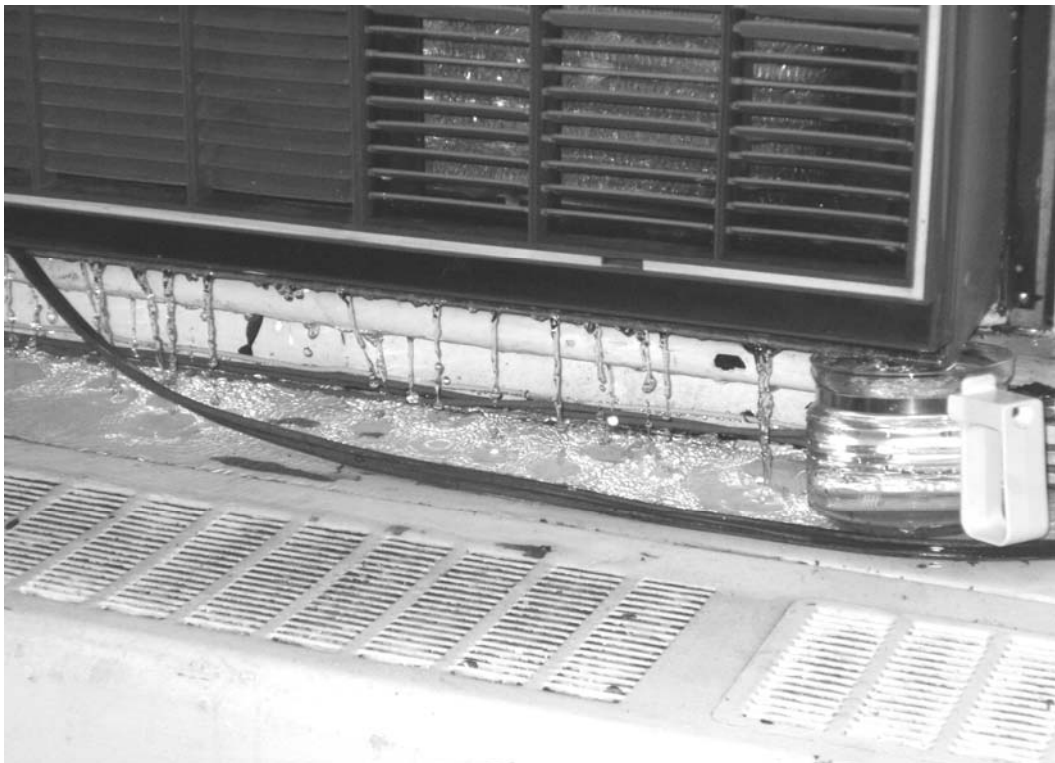
Picture 4

During the fall of 2005, New England experienced a stretch of heavy rainfall and flooding in September and October. As an example, the general Berkley vicinity had approximately 3.5 inches of rain on September 15 and 16, 2005, as well as 6.7 inches of rain on October 14 and 15, 2005 (The Weather Underground, 2005). Pictures taken by Phyllis Brennan, Berkley Board of Assessors, on September 15, 2005, depict substantial water penetration through windows, wet carpeting, water damage to stored materials and water pooling on the basement floor (Pictures 4 through 9).

**Water Penetrating Into Building under Window-Mounted Air Conditioner
(Photo By Phyllis Brennan, Berkley Board of Assessors, 9/15/2005)**

4. Remove leaves from basement entrance shown in Picture 29 to determine if drain is present, if so; ensure that the drain works appropriately.
5. Reinstall window-mounted air conditioners in a manner to prevent water penetration and drafts.

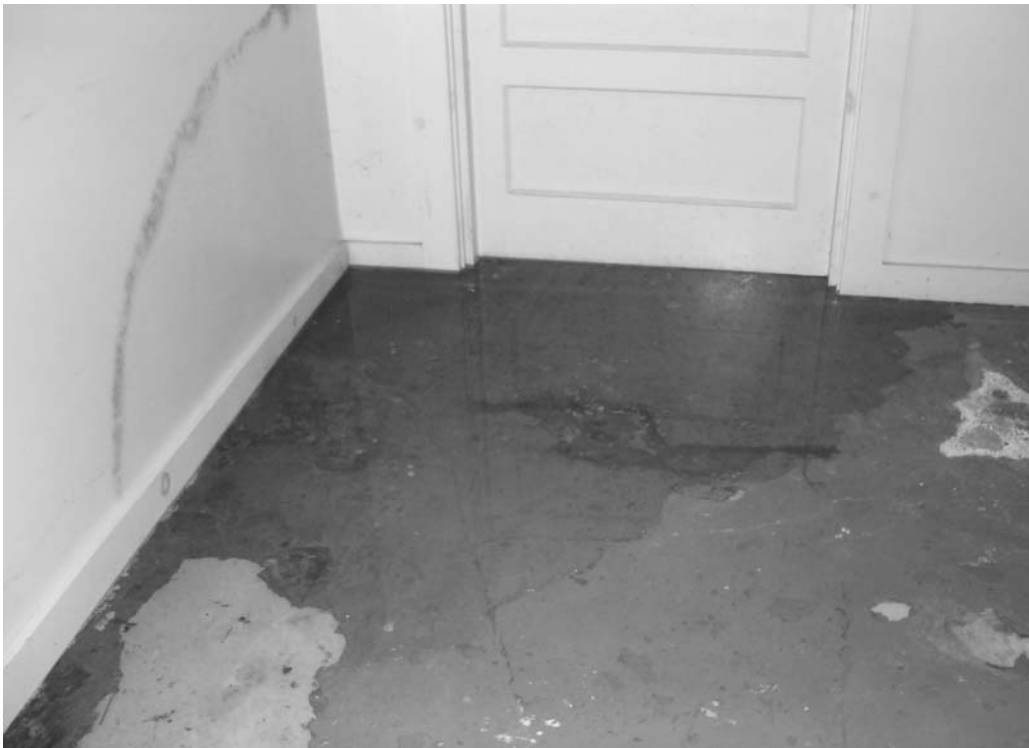
Picture 5

Records Room Entrance (Room 8)
(Photo By Phyllis Brennan, Berkley Board of Assessors, 9/15/2005)

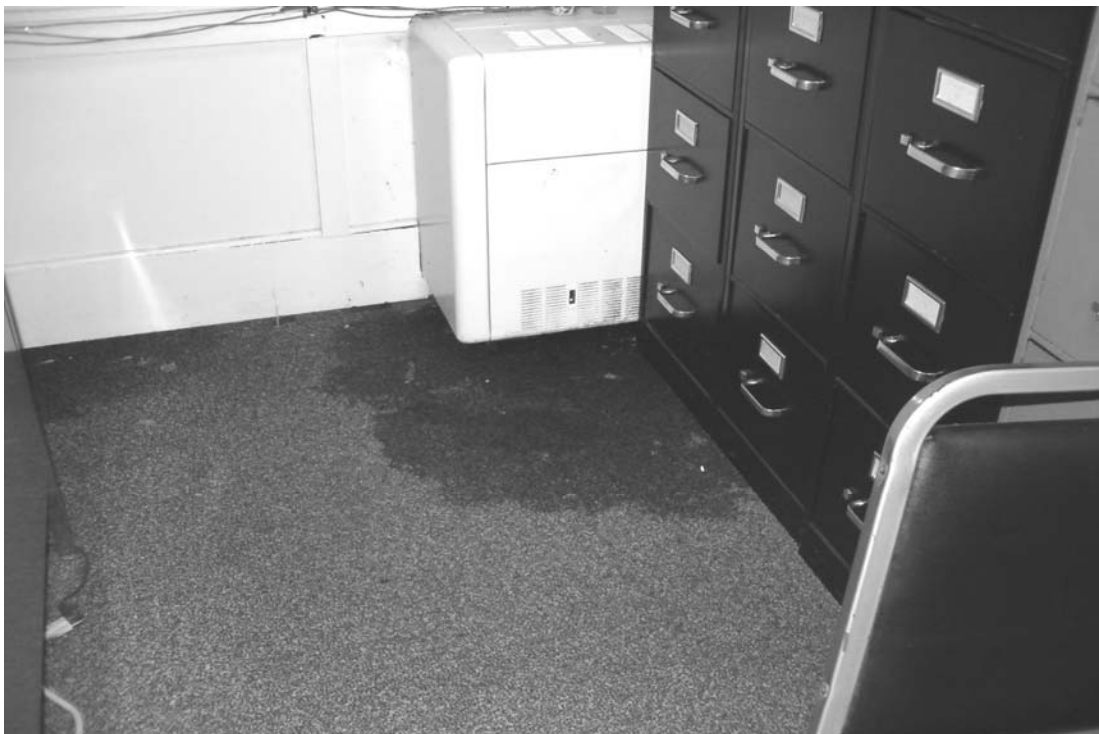
Picture 6

Water Damaged Carpet, Room 2
(Photo By Phyllis Brennan, Berkley Board of Assessors, 9/15/2005)

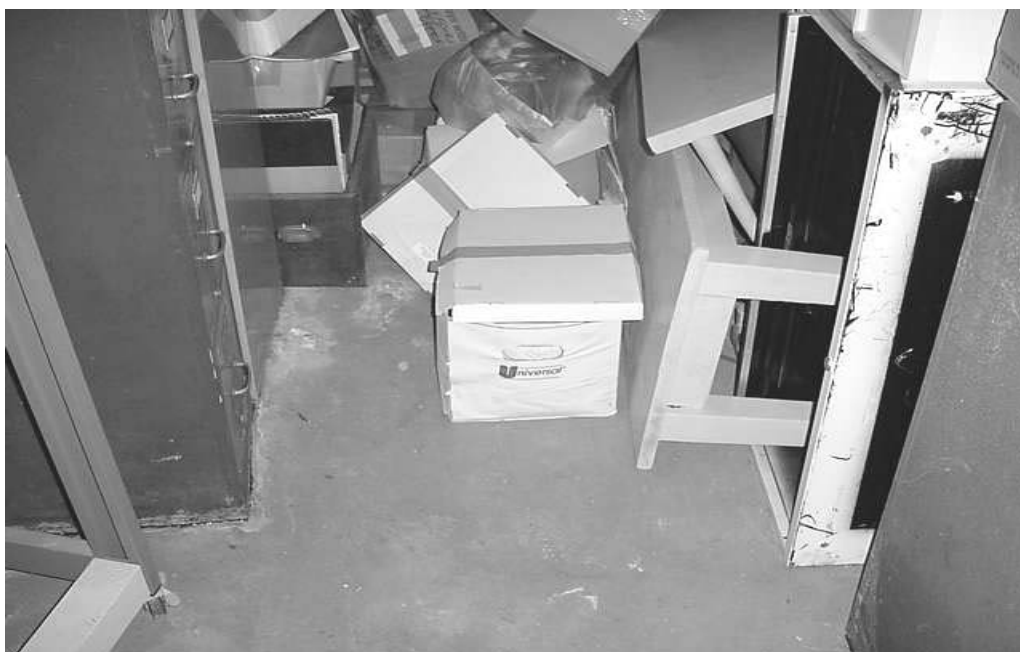
Picture 8

Water damage and mold colonization of stored materials and building components were found in every accessible location in the basement. Materials such as cardboard boxes (Pictures 7 and 8), paneling (Picture 9), gypsum wallboard (Picture 10), ceiling plaster and ceiling tiles (Pictures 11 and 12), and wood (Picture 13) all had visible mold colonies. Other stored materials also showed signs of mold colonization or water damage (Pictures 14 through 18).

Mold Colonized Boxes, Room 8 (Compare To Picture 7)

The creation of an unconditioned space in the basement without the means to control temperature or relative humidity have created conditions that subjected stored materials (e.g., book collections and museum artifacts) to mold colonization. A decision should be made concerning the mold contaminated materials stored in this area. These books, boxes, documents and other materials will continue to be a source of mold associated particulates/odors, unless the items are removed/remediated. As an initial step, options concerning the preservation of materials stored in this area should be considered. Porous materials that are judged not worthy of preservation, restoration or transfer to another media (e.g., microfiche or computer scanning) should be discarded. Where stored materials are to be preserved, restored or otherwise handled, an evaluation should be conducted by a professional book/records conservator. This process can be expensive, and may be considered for conservation of irreplaceable documents that are colonized with mold.

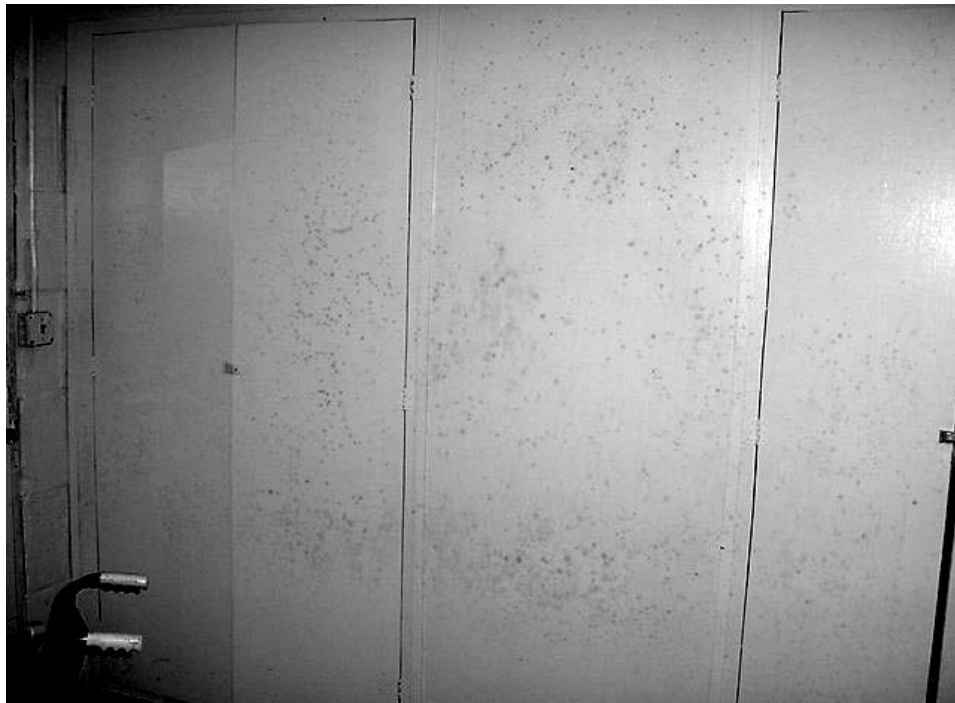
Picture 9

Mold Colonized Paneling

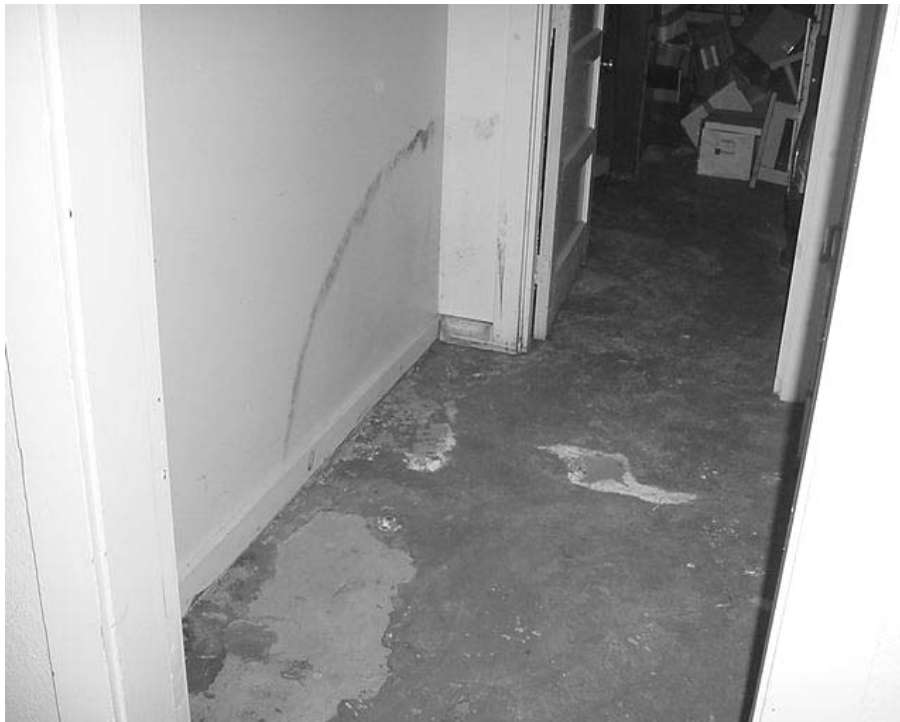
Picture 10

Water Damaged Gypsum Wallboard, Basement

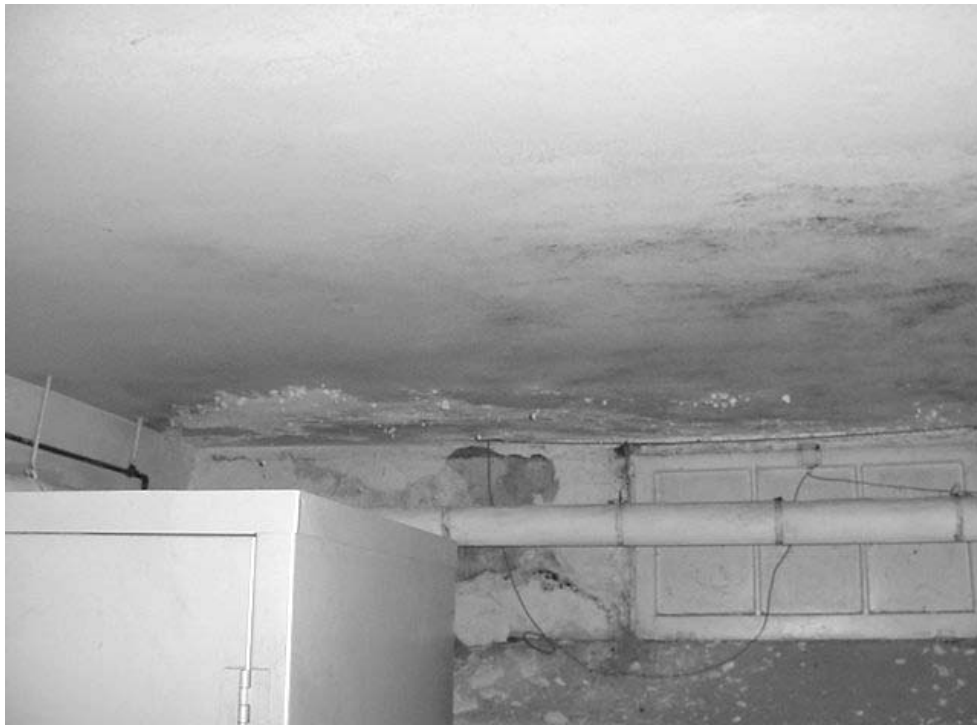
Picture 11

Mold Colonized Ceiling Plaster, Basement

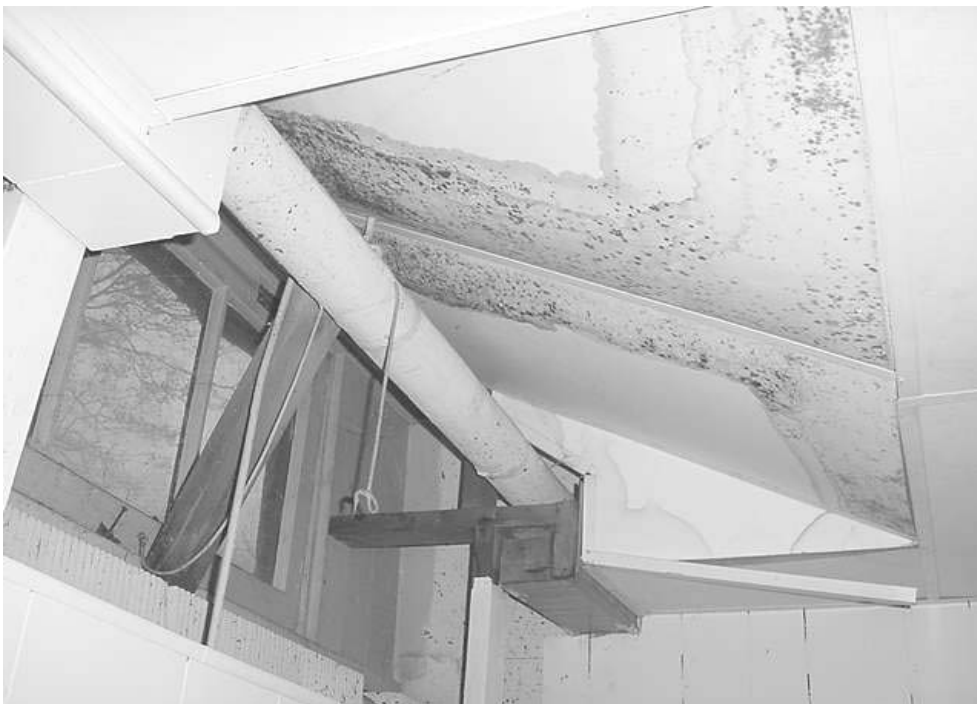
Picture 12

Water Damaged Ceiling Tiles

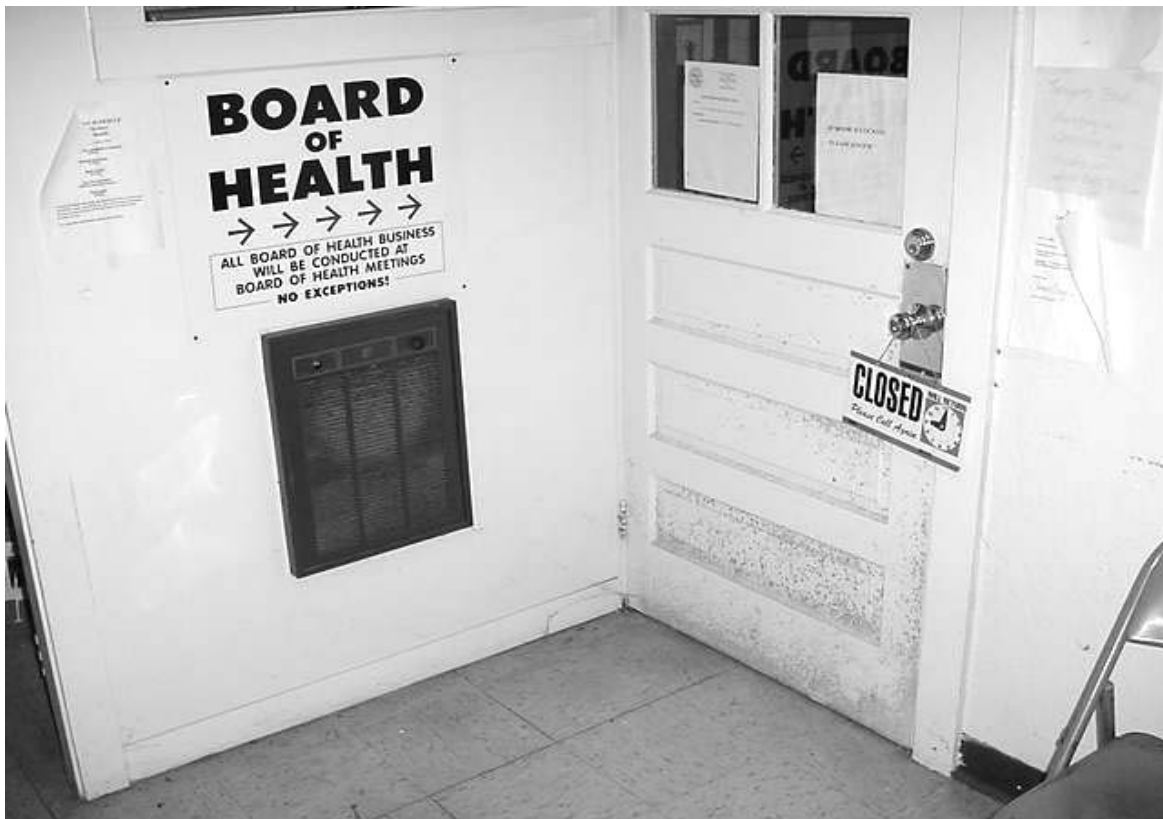
Picture 13

Mold Colonized Door, Basement

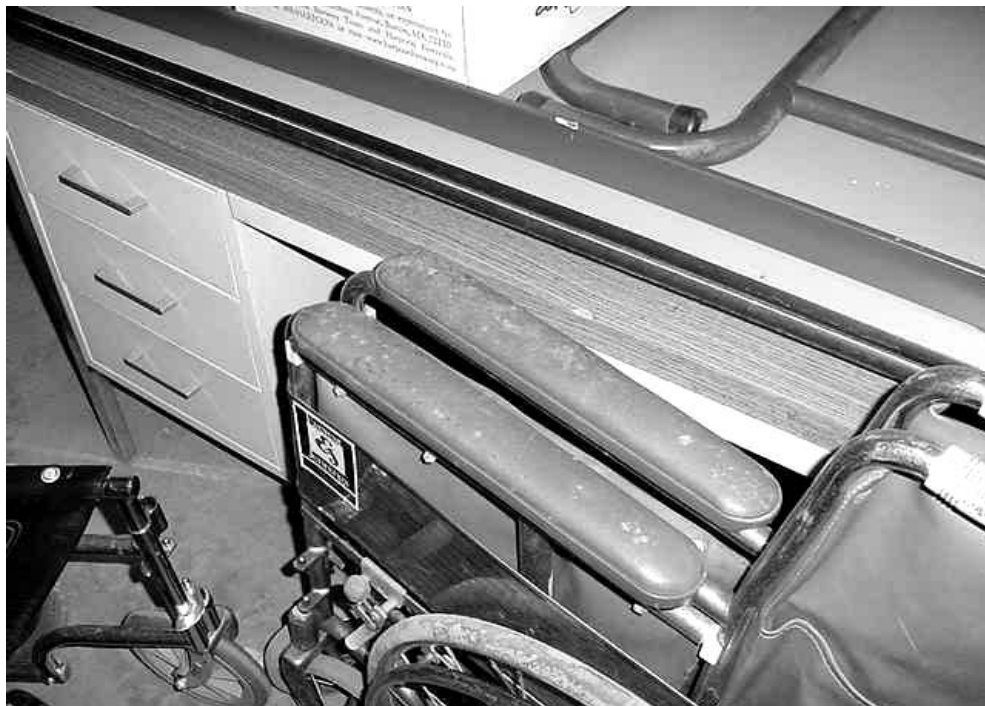
Picture 14

Mold Colonized Wheel Chair, Basement

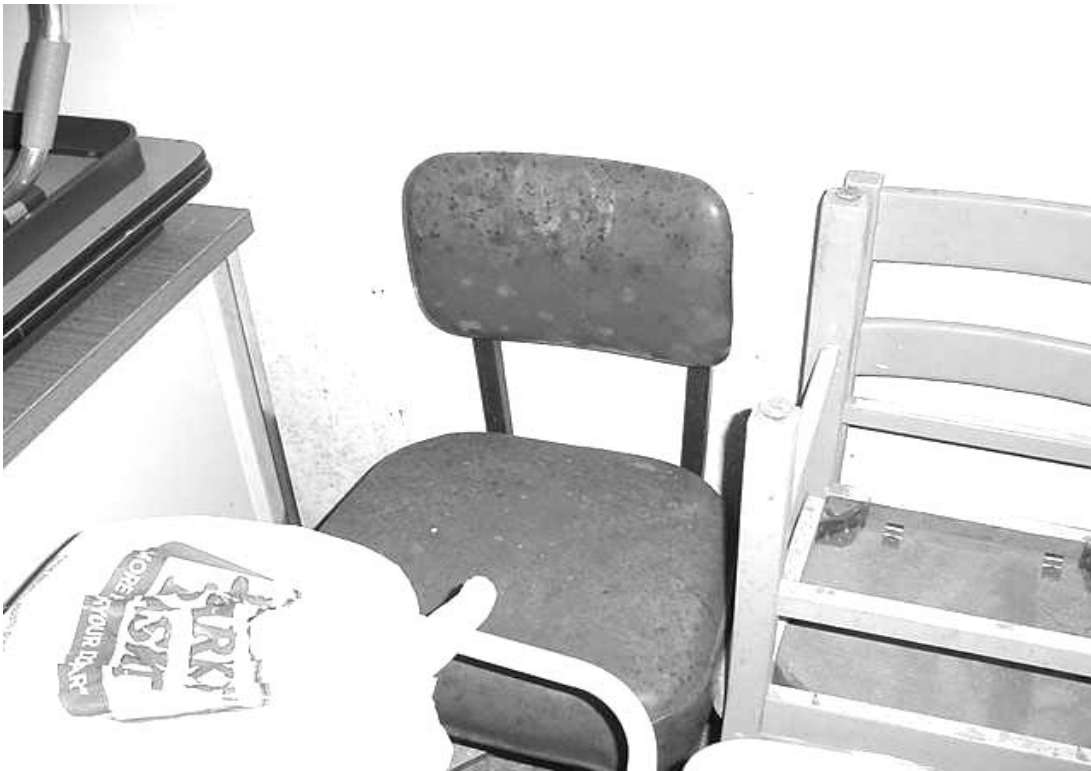
Picture 15

Mold Colonized Chair Basement

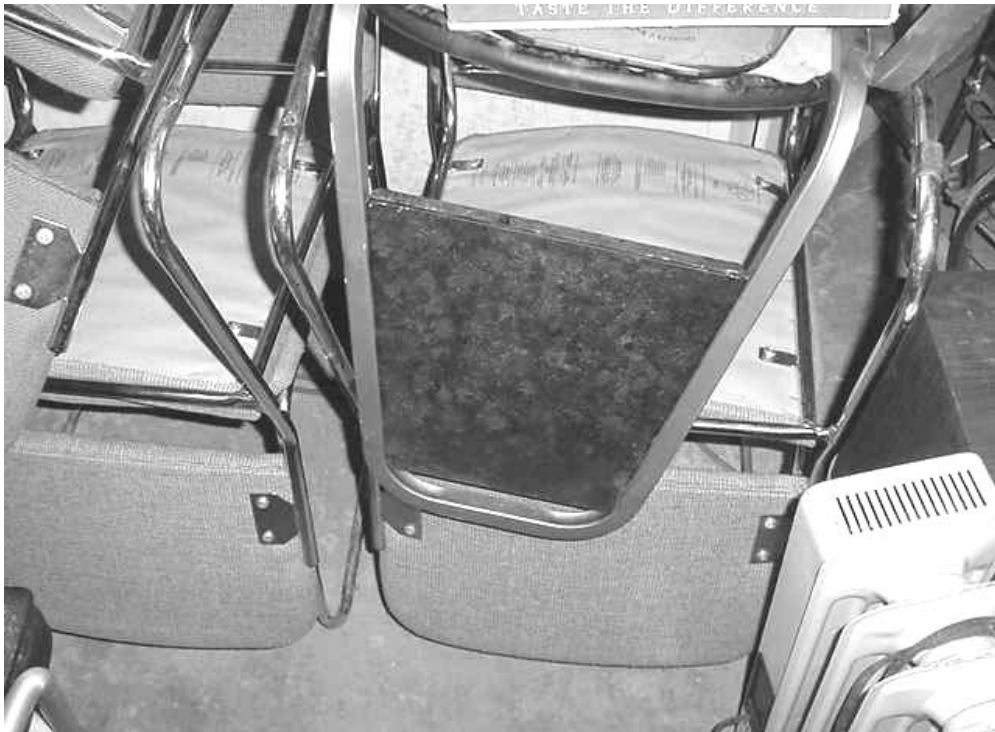
Picture 16

Mold Colonized Chair, Basement

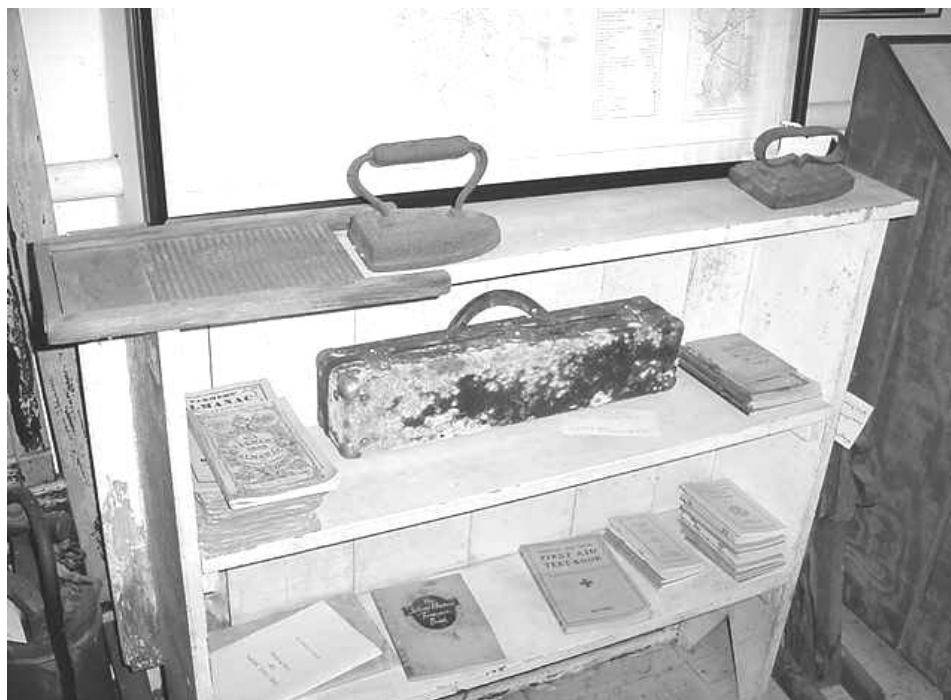
Picture 17

Mold Colonized Instrument Case in Museum, Basement

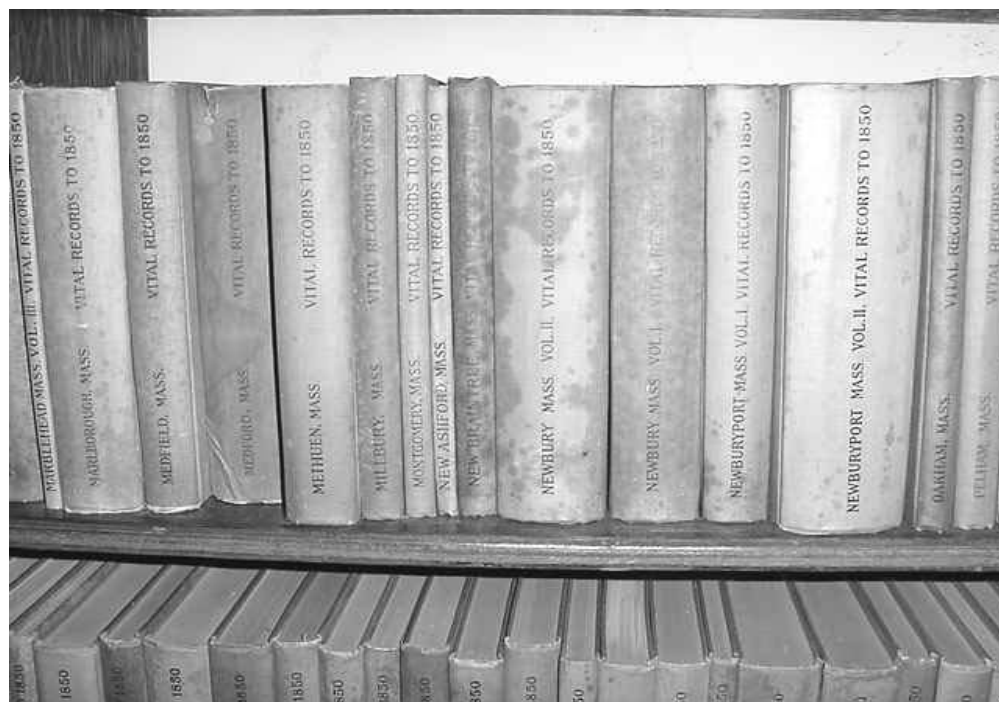
Picture 18

Mold Colonized Books in Museum, Basement

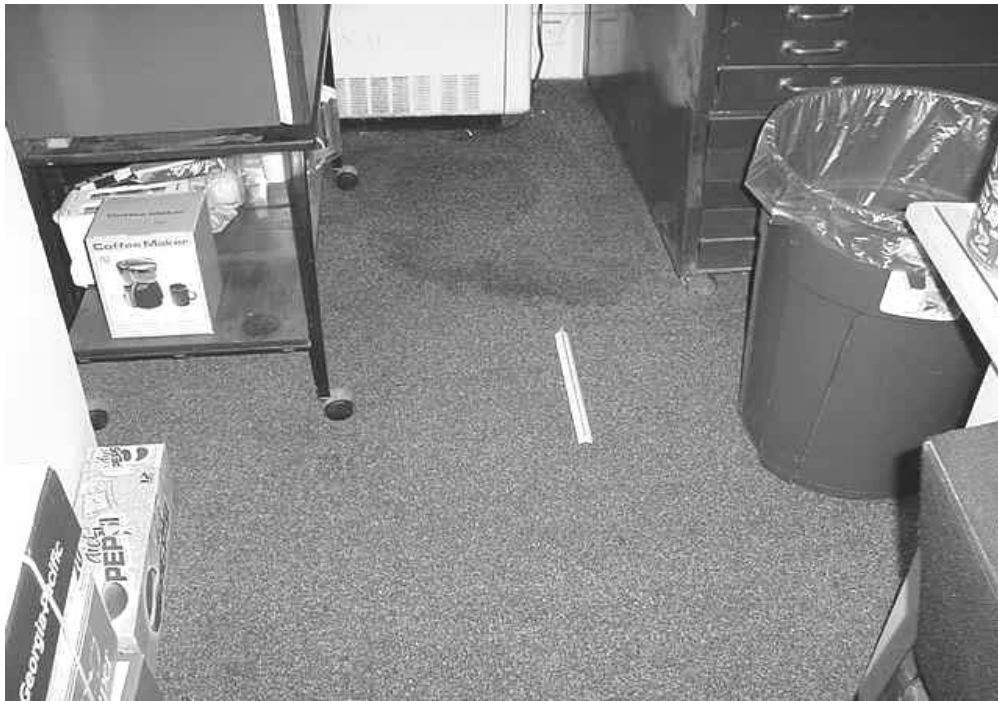
Picture 19

In an effort to ascertain moisture content of flooring materials in the building, samples were taken in carpeting on the first floor (Table 1). A Delmhorst probe was inserted into carpet or into seams of plywood flooring. The Delmhorst probe is set to sound a signal when a moisture reading of ≥ 15 in wood is detected. The the wood floor and carpet in the room 2 was saturated several feet from the window (Picture 19) on the day of the assessment.

**Water Saturated Carpet in Room 2
(Ruler on Floor Indicates Edge of Carpet Saturation from Exterior Wall)**

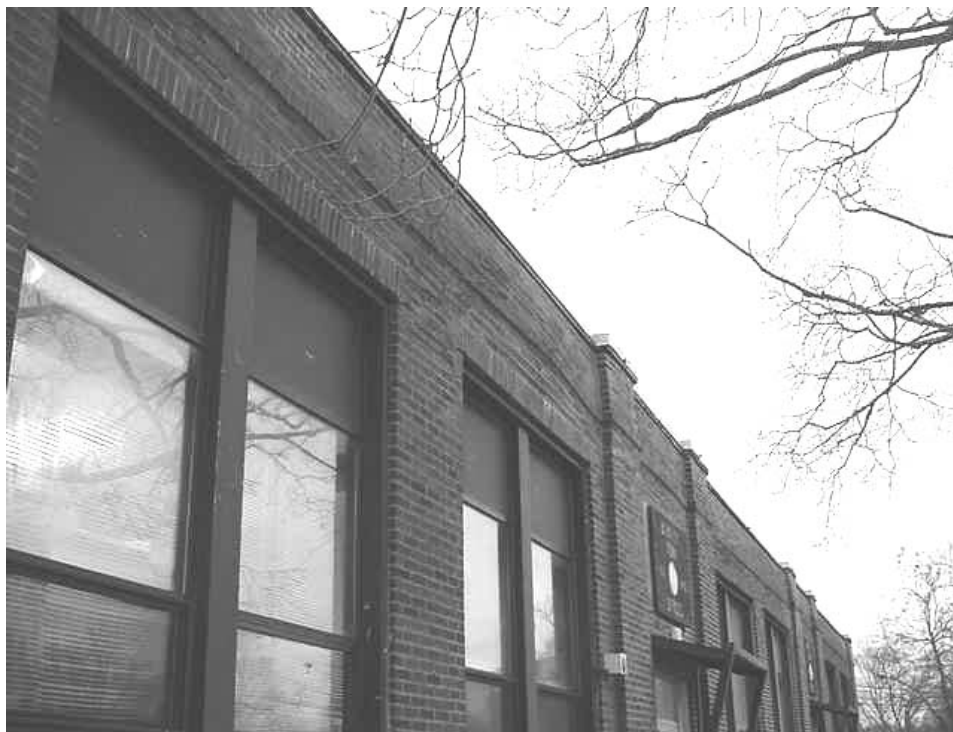
Picture 20

- A section of wall above the front windows of the selectmen's office and south door are notably bulging outward (Pictures 20 and 21). The south door was ordered to be locked and blocked off by the Berkley Inspector of Buildings ([Appendix B](#)).

Bulging Exterior Wall above Board of Selectmen's Office

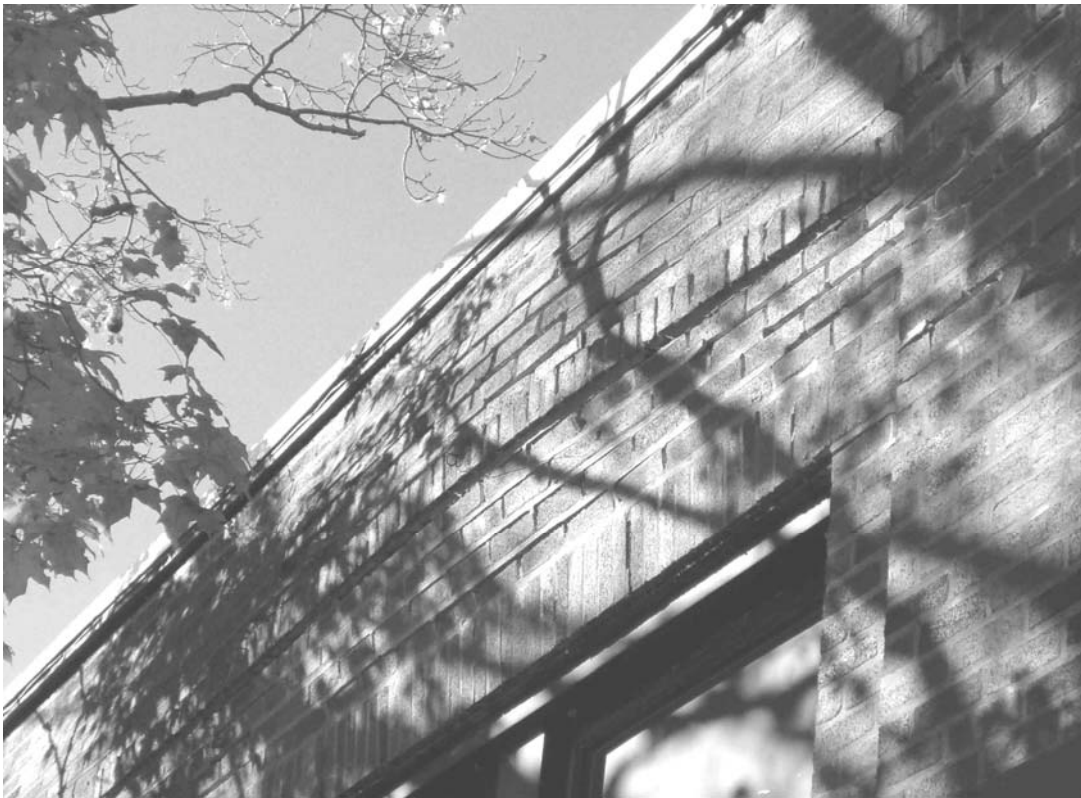
Picture 21

**Close up of Bulging Exterior Wall above Board of Selectmen's Office
(Photo By Phyllis Brennan, Berkley Board of Assessors, 9/15/2005)**

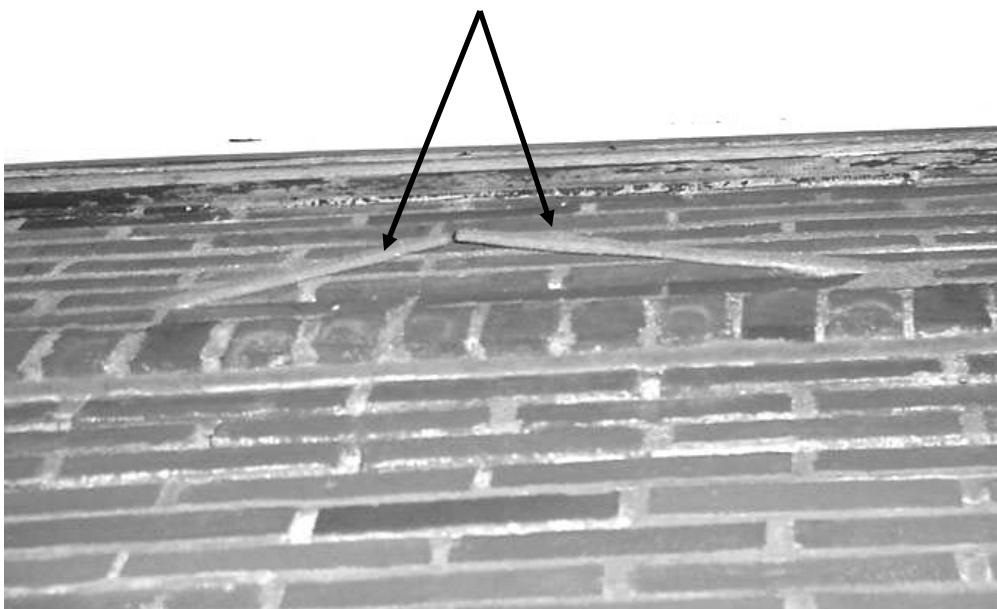
Picture 22

- Numerous areas of missing/failing mortar between exterior wall bricks were noted (Picture 22). In some cases, spray foam insulation was applied to these spaces (Pictures 23 and 24) which would hold water inside the exterior wall cavity. (Spray foam insulation is a water impermeable material that would dam water behind brick and mortar. Brick and mortar are porous materials through which water may pass.)

Failing Mortar, Exterior Wall

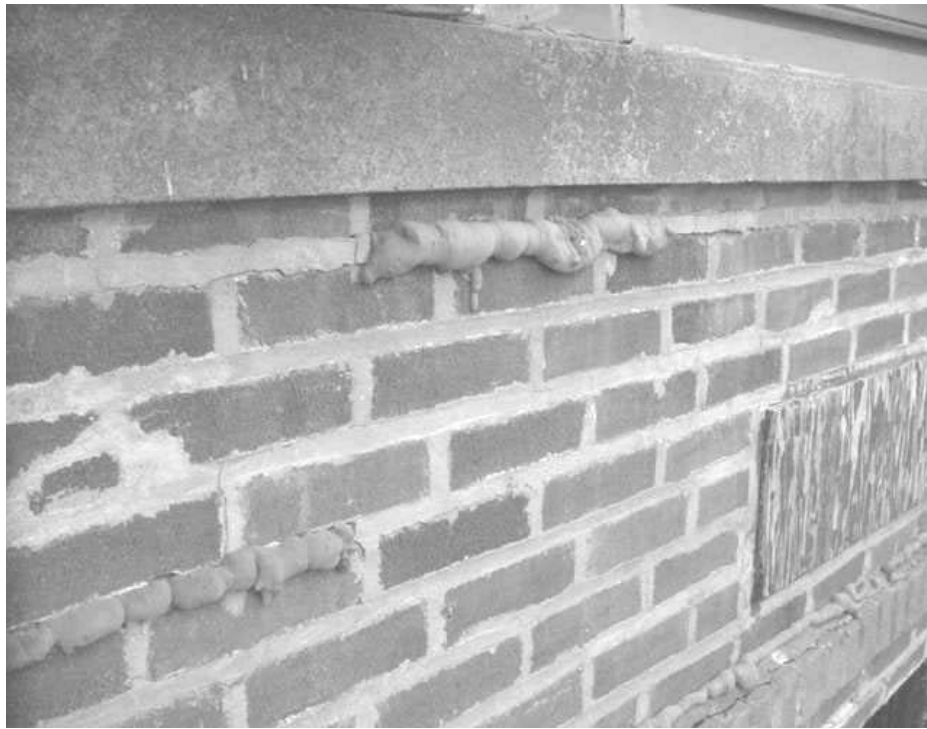
Picture 23

Spray Foam Insulation Inserted Into Mortar Joint, Front Exterior Wall

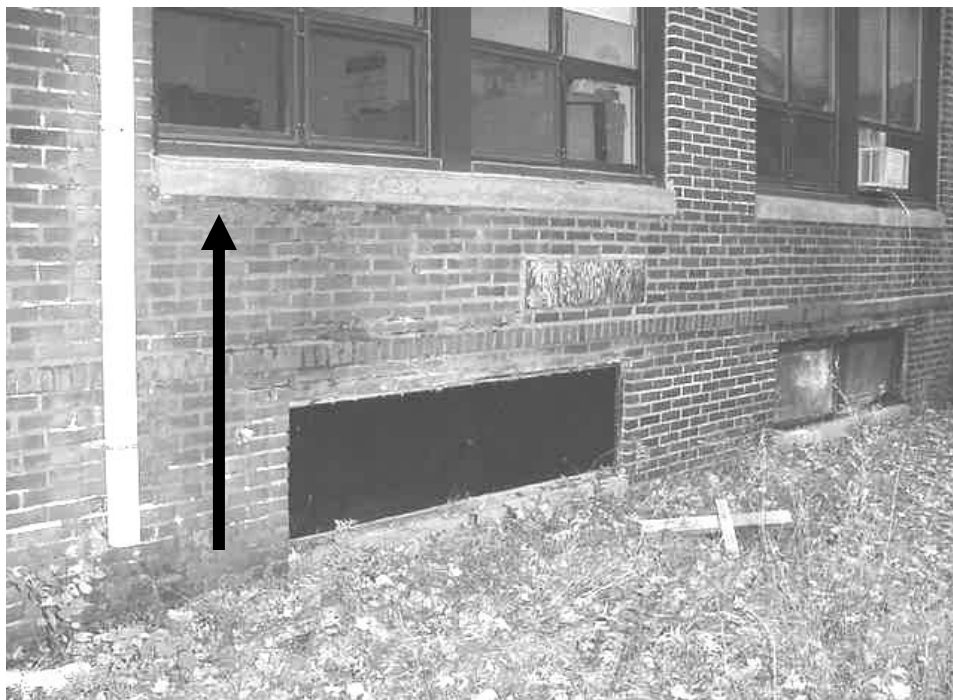
Picture 24

Spray Foam Insulation Inserted Into Mortar Joint, Rear Exterior Wall

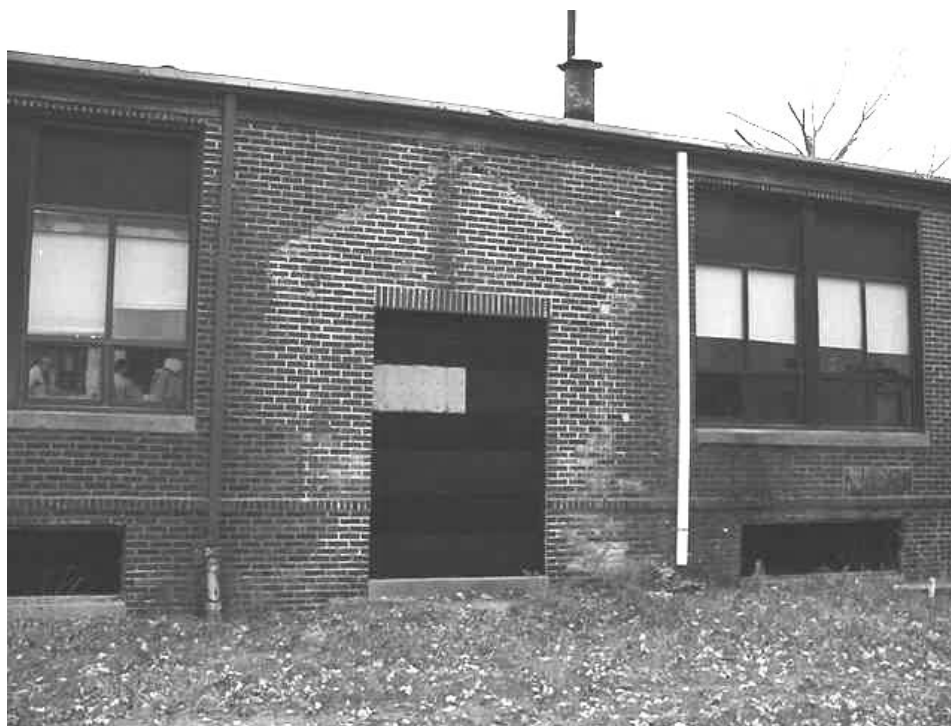
Picture 25

- A large breach exists in the rear exterior wall of the building (Picture 25). During renovations of the BTOB, building occupants indicated that the building originally had a rear entrance that was sealed to create restrooms. The opening for the former door appeared to be only covered with tar paper. In the experience of CEH staff, an aperture in the building envelope is usually sealed with a like material to that of the building envelope, in this case brick and mortar.

Former Entrance, Rear of Building

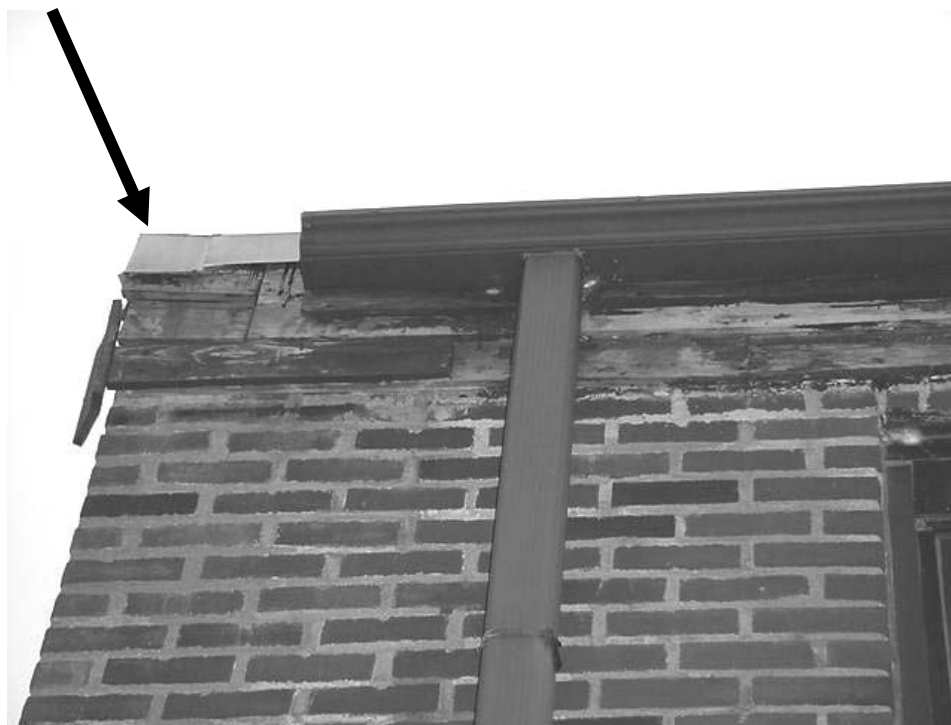
Picture 26

- Areas of the roof are missing flashing (Picture 26).
- Downspouts appear to be clogged, as evidenced by moss and water staining on the exterior wall behind the pipe joints (Picture 27).
- Condensation on the inside of energy efficient windows indicates that the gaskets have failed, allowing moisture penetration (Picture 28).
- Air conditioners were installed in a manner that allows driving rainwater to penetrate, wetting window sills and carpeting (Picture 4).
- A basement entrance exists at the rear of the building (Picture 29). The door is water damaged and the floor of the threshold is covered with accumulated leaves, which would block drainage, if one exists.

Missing Roof Flashing, Northeast Corner of Building

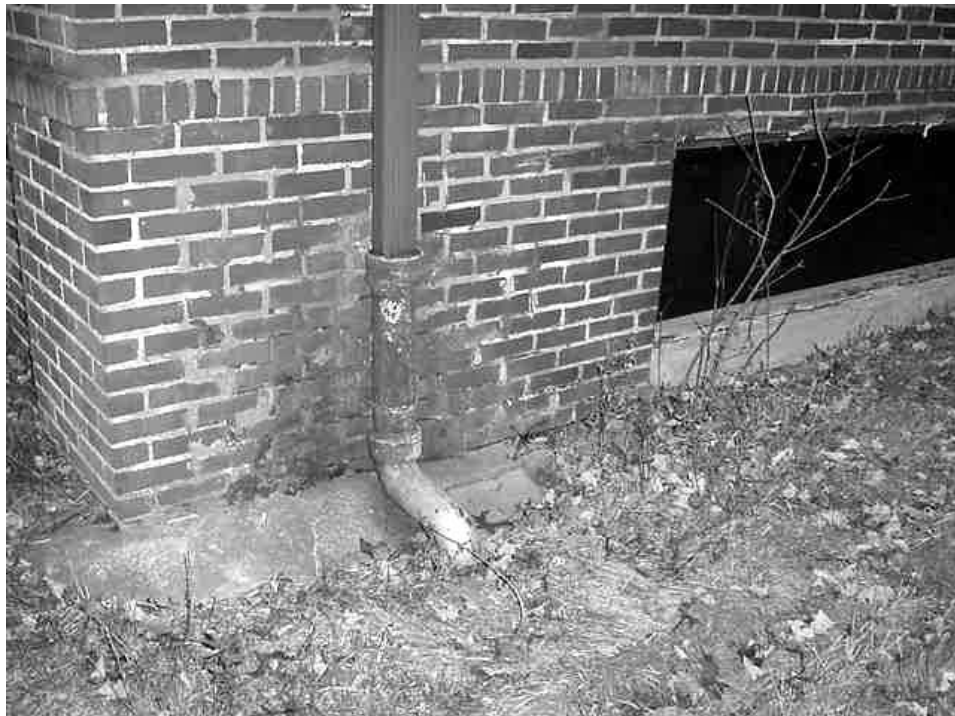
Picture 27

Moss and Water Staining In the Exterior Wall behind the Pipe Joints Indicates Clogging

6. Make repairs to gutter/downspout system to drain water away from the building.
7. Replace water damaged door to the basement rear entrance.
8. Use openable windows to provide air exchange. Care should be taken to ensure windows are properly closed at night and weekends to avoid the freezing of pipes and potential flooding.

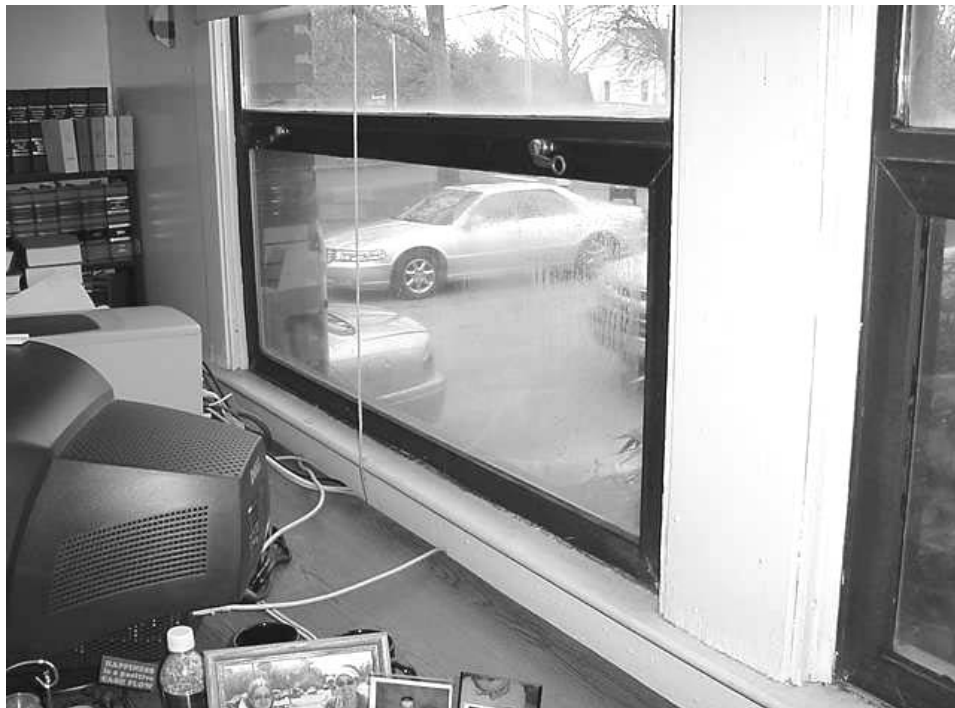
Picture 28

Condensation inside Window Sash

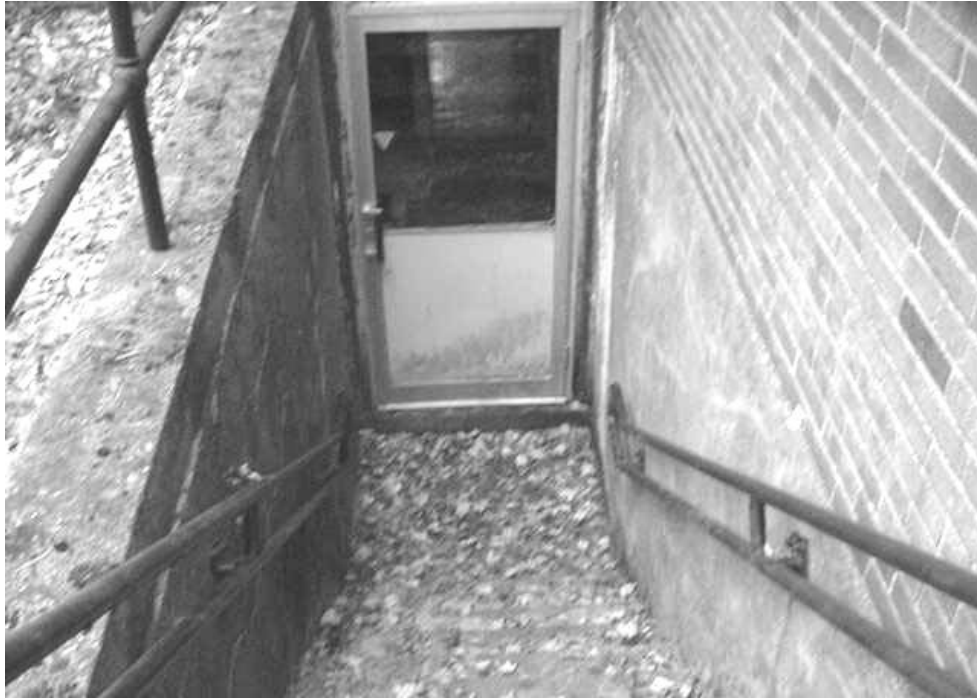
Picture 29

Basement Entrance, Note Leaves
